# New York State Department of Transportation

## Yellow Flag NB2358W004

**BIN: 1065318**

**Feature Crossed: 6TH AVENUE**

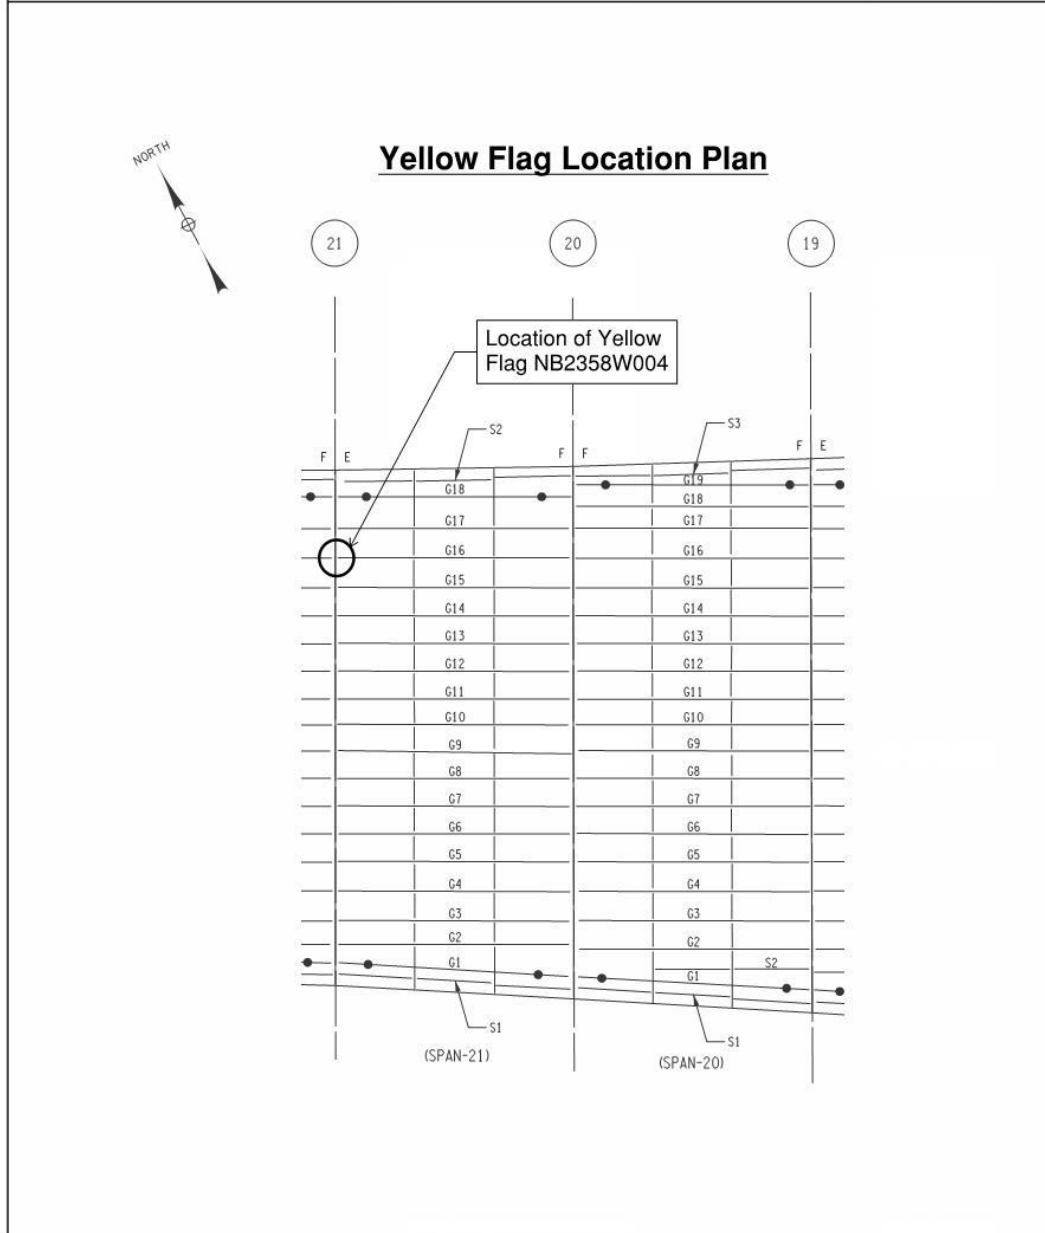
**Flag Photographs**Photo Number: **1**Photo Filename: **23\_Flag Location Plan.jpg**Gowanus Expressway  
2023 Biennial Inspection - Field SketchBIN: 1065318Team: AA/TSDate: 04/20/2023Span: 21Location: Girder G16 at Pier 21

**Attachment Description: Flag Location Plan**

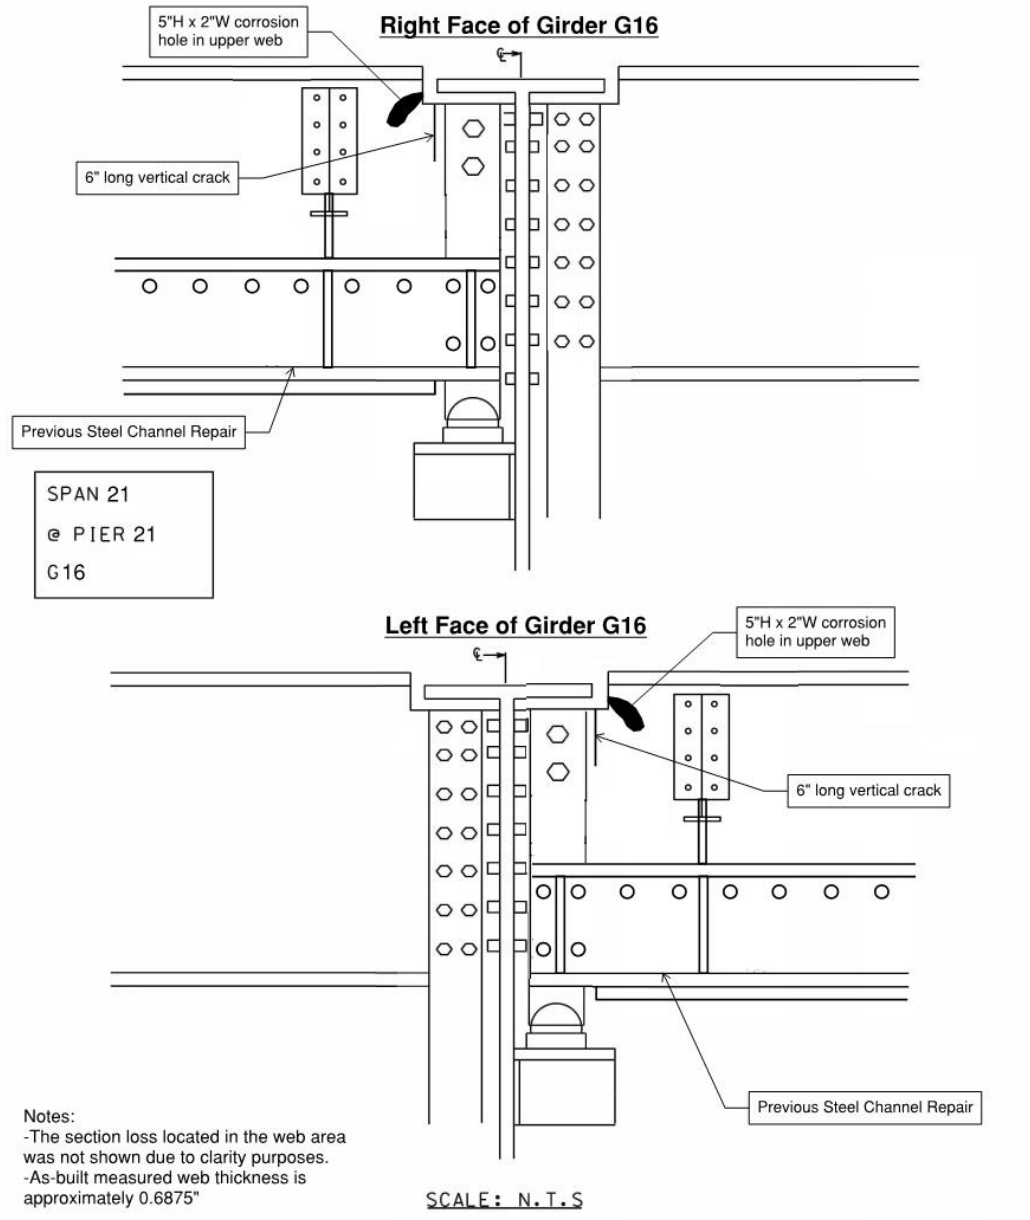
Photo Number: 2

The end of Girder G16 on the Span 21 Side of Pier 21 exhibits a 6" long vertical thru crack in the girder web starting at the top cope adjacent to the guide angle (Photos 5 and 6) and is in the upper web above a previous repair to the lower web above the bearing (refer to Yellow Flag Condition sketch #2 for more details).

**Attachment Description: Flag Condition Sketch**

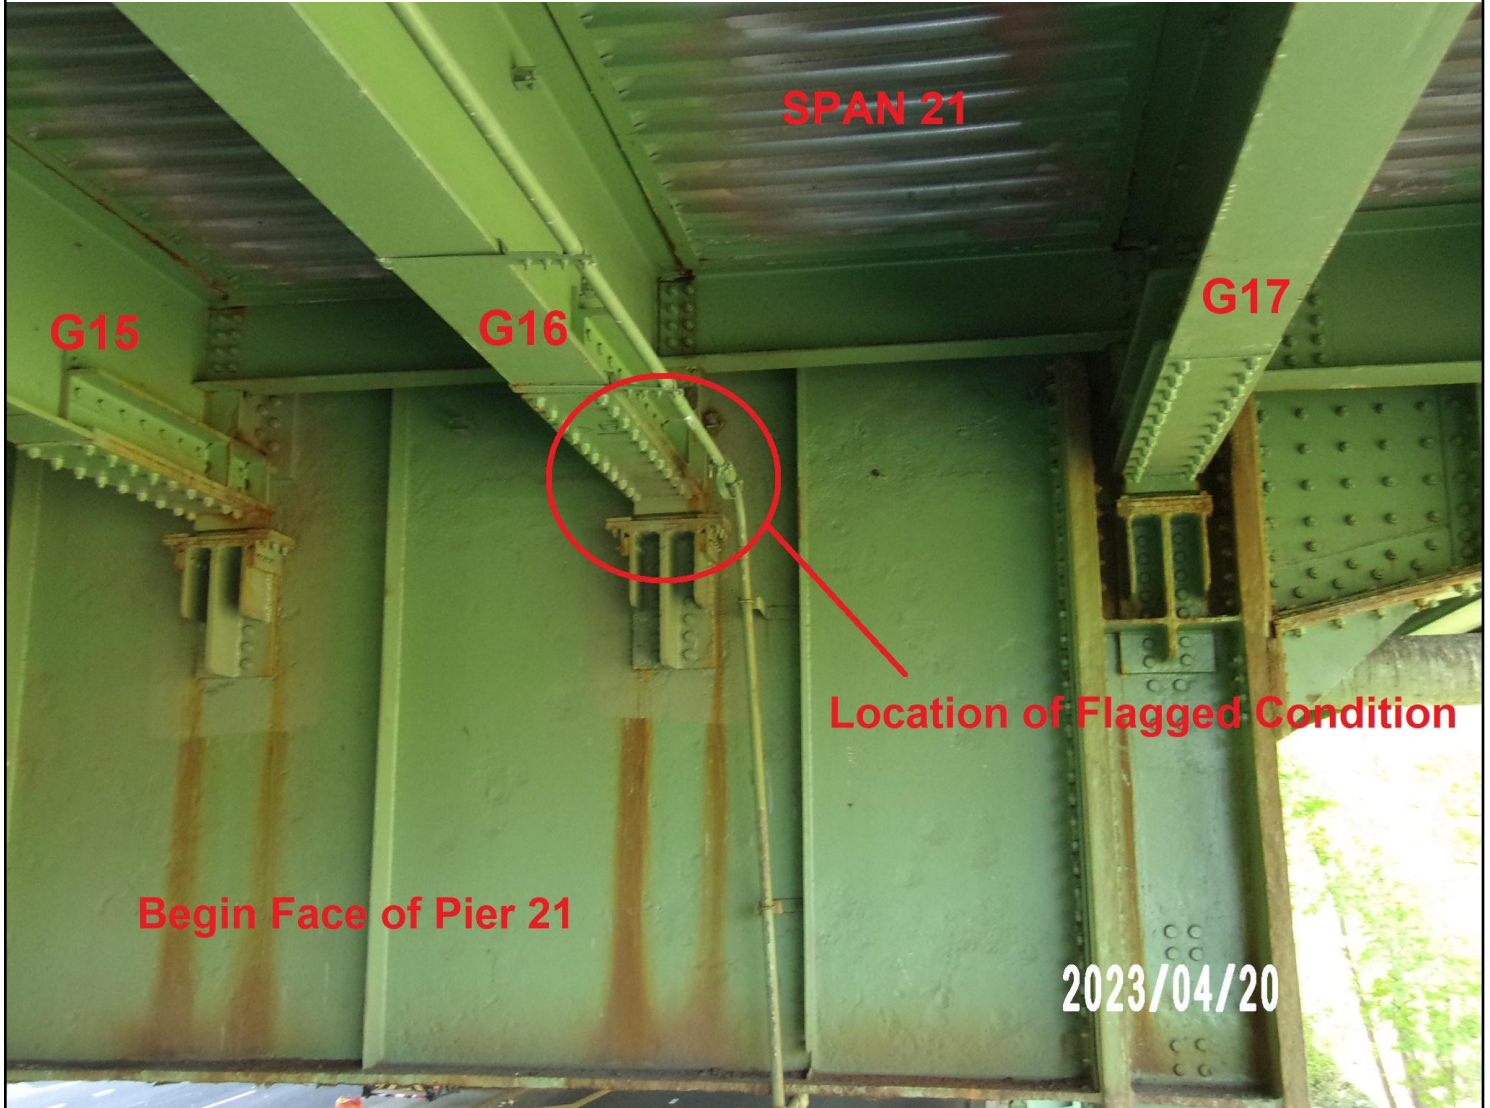
Photo Number: 3

**Attachment Description:** General view of the flagged location at Girder G16 in Span 21 at Pier 21. Looking End.

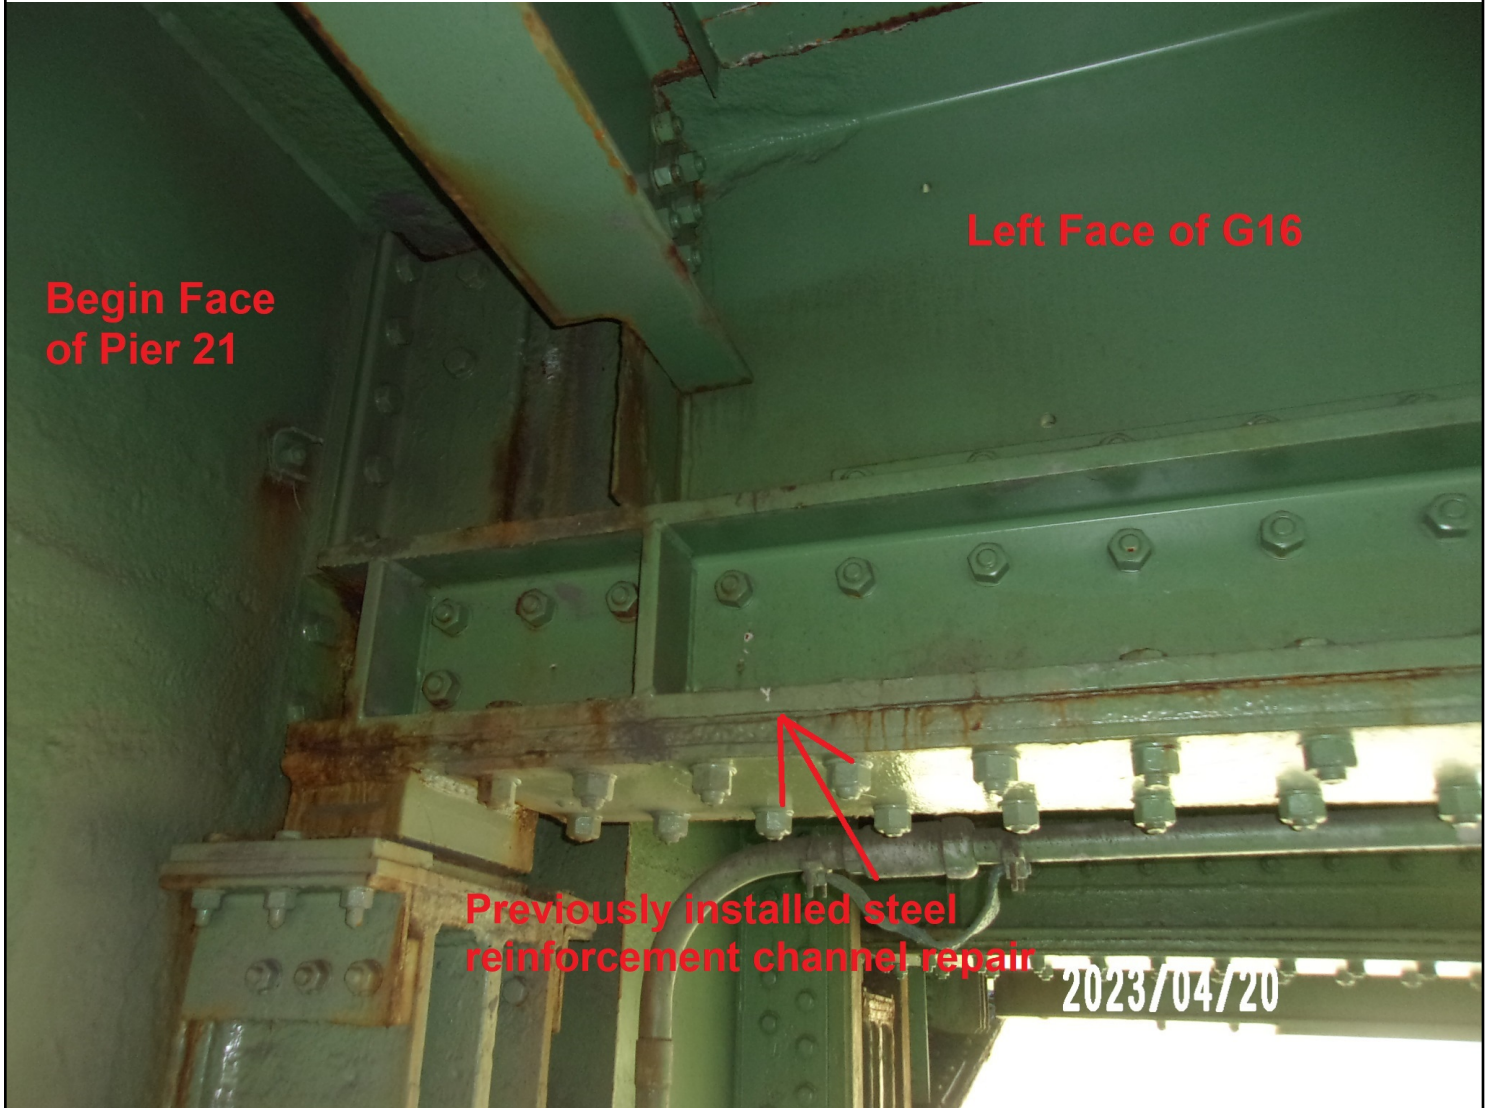
Photo Number: 4

1. This girder location has previously installed steel reinforcement channel repair approximately 9.5" high in the lower web above the bearing which is in good condition (Photo 4).
2. Adjacent Girders G15 and G17 have previously installed steel reinforcement channel repairs which are in good condition.
3. A single lane closure in the right lane on EB roadway and 30ft bucket truck are required to access this location.
4. The previous 2021 Biennial Report did not have any documentation for the above girder location.

**Attachment Description:** General view of the left face of Girder G16 in Span 21 at Pier 21. The girder end has previously installed steel reinforcement channels in the lower web above the bearing which are in good condition. Looking Right.

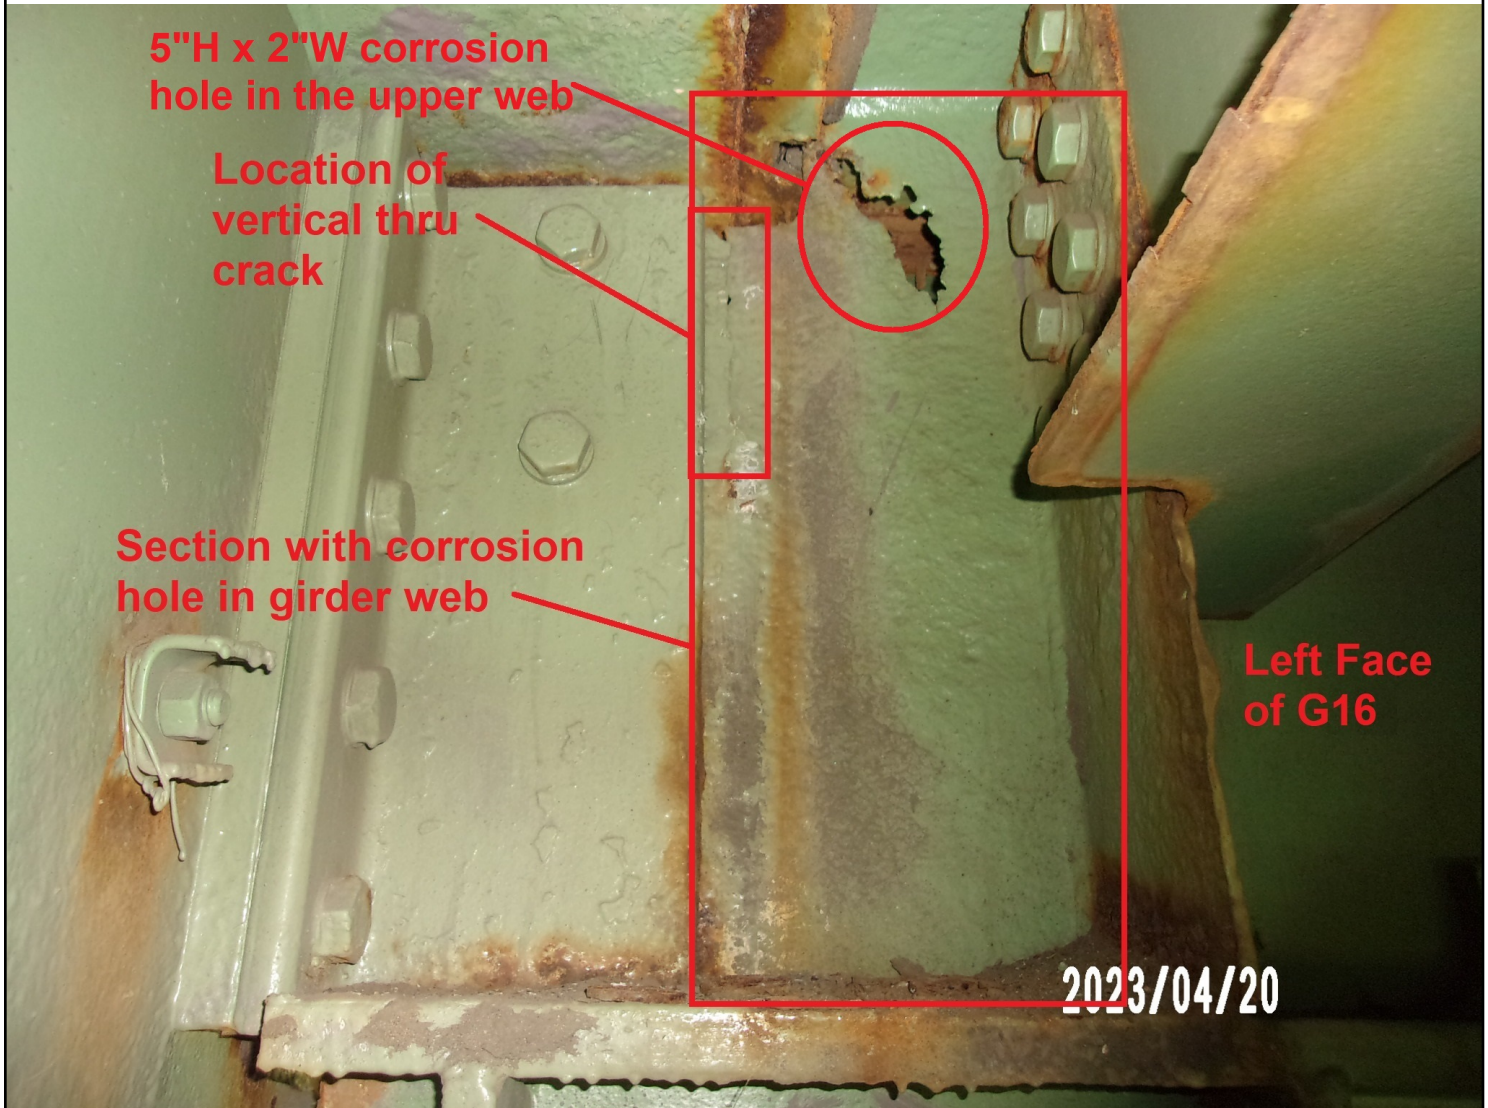
Photo Number: 5

The web area above the bearing and above the channel repair exhibits 3/8" remaining thickness measured (RTM) for full web height along the guide angle for 19.5"H x 2"W and 1/4"-3/8" RTM in the upper web at the top cope for 14"H x 4"W with 5"H x 2"W corrosion hole within the section loss area (Photo 5).

**Attachment Description:** The left face of Girder G16 in Span 21 at Pier 21. The girder web exhibits 6" long vertical thru crack starting at the top cope. Also, the girder web area above the steel repair channels exhibits section loss with remaining thickness measured ranging from 1/4"-3/8" with corrosion hole in the upper web. Looking Right.

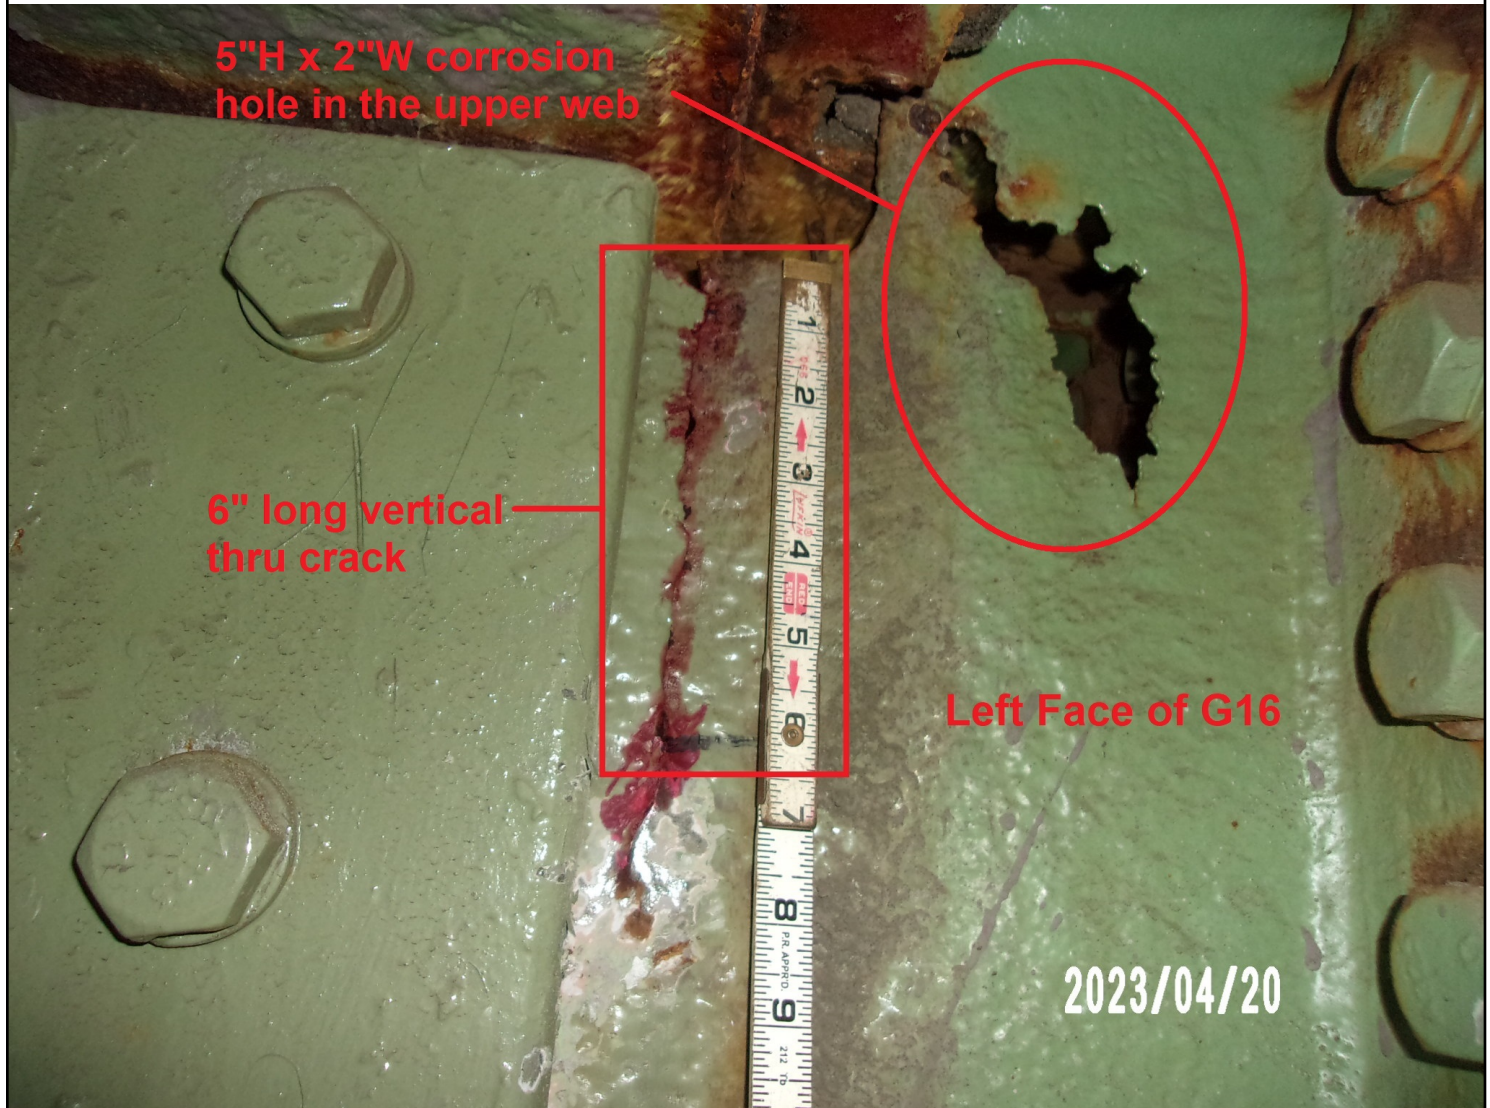
Photo Number: 6

**Attachment Description:** The left face of Girder G16 in Span 21 at Pier 21. Close up view of the 6" long vertical thru crack in the girder web starting at the top cope. Looking Right.
